ILLINOIS NATURAL HISTORY SURVEY

Effect of
Permanent Flooding
in a River-Bottom Timber Area

August 1949

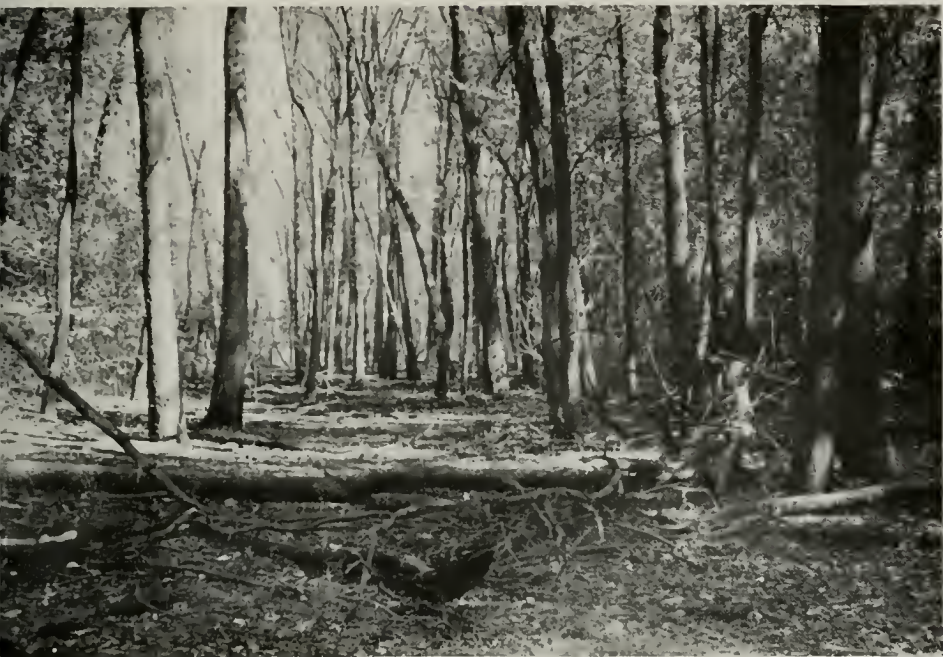
Fig. 4.—Typical stand of silver maple on a "flat" site, October, 1940. Dead and dying trees in background.

Silver or soft maple was the most abundant of the large trees in the flooded area. On the lowest level on which trees grew, it easily dominated all plants except semiaquatic species, such as black willow, buttonbush, waterprivet, and waterlocust, fig. 4. Many of the maple

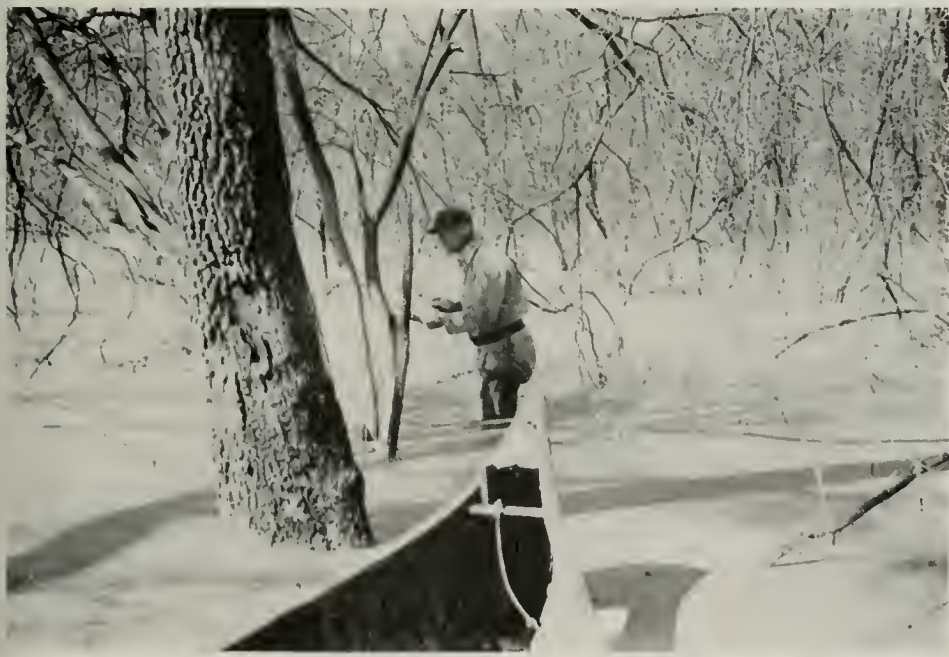
Fig. 6.—Most trees and shrubs flooded to depths above the root collar died in 1 to 6 years. Shown above is a waterprivet, relatively resistant to flooding, that died during the fourth year when flooded 20 inches. The large tree is a persimmon, which died during the second year. A heavy mat of duckweed covered the water in this area. The writer, taking notes, October, 1941.

Virtually all trees permanently flooded to a depth of 20 or more inches were dead by 1946, 8 years after the initial impoundment, fig. 6. Species varied considerably in rate of mortality, table 2. Only

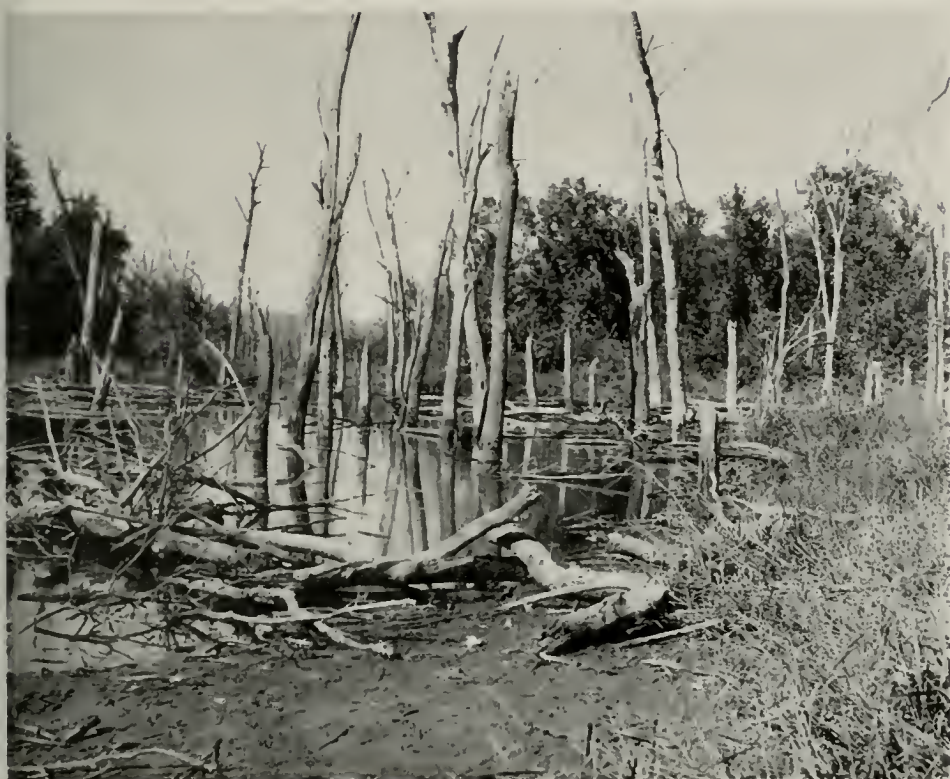
Fig. 7.—Diameter of tree or shrub had little effect on survival after flooding except in semi-aquatic species and in reproduction sizes. In the area pictured above, all trees of 3 to 30 inches (larger trees in background) had succumbed by October, 1946, in 8 years of permanent flooding.

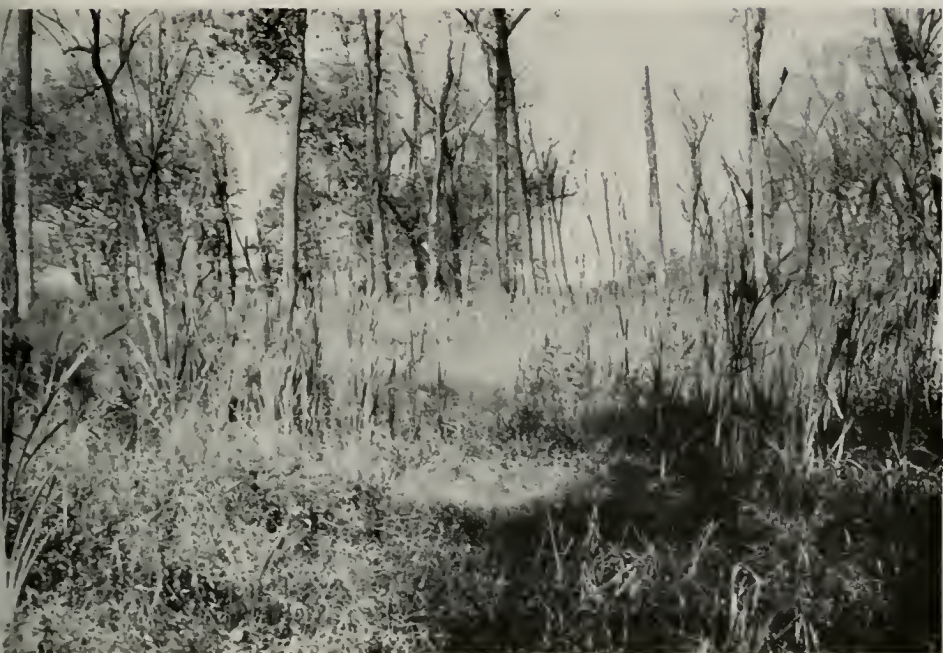
Fig. 8.—Cattail, rice cutgrass, duckpotato, smartweed, and other marsh or moist-soil plants invading timberland where the water table had been raised to the soil surface. Timber stand is dead or dying, October, 1941.

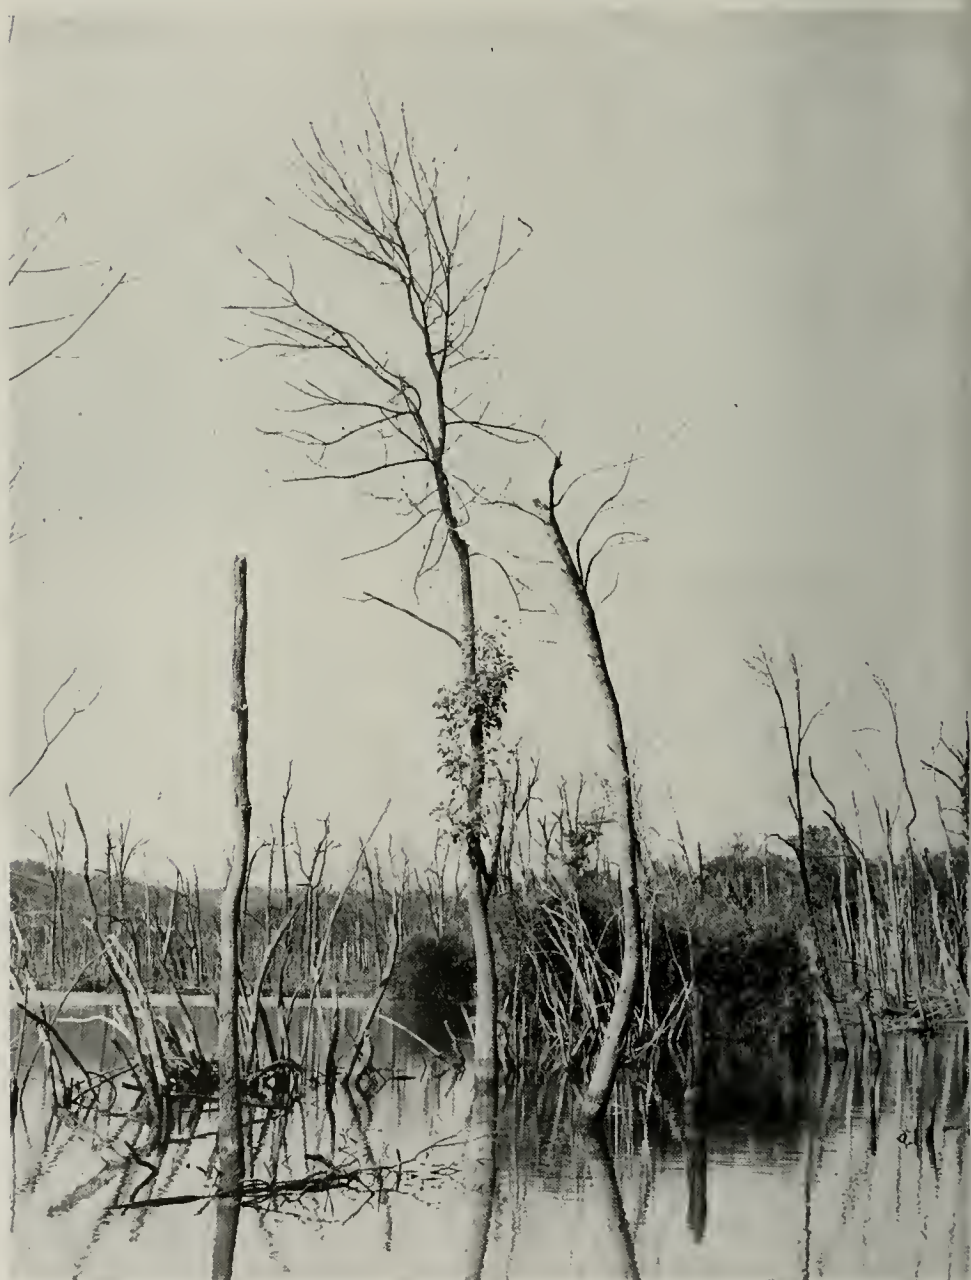
Fig. 9.—White ash was among the tree species most resistant to flooding. A few vigorous individuals, in less than 2 feet of water, threw trunk sprouts in 1946, during the ninth year of flooding. Two recently built duck blinds are shown in the center background.

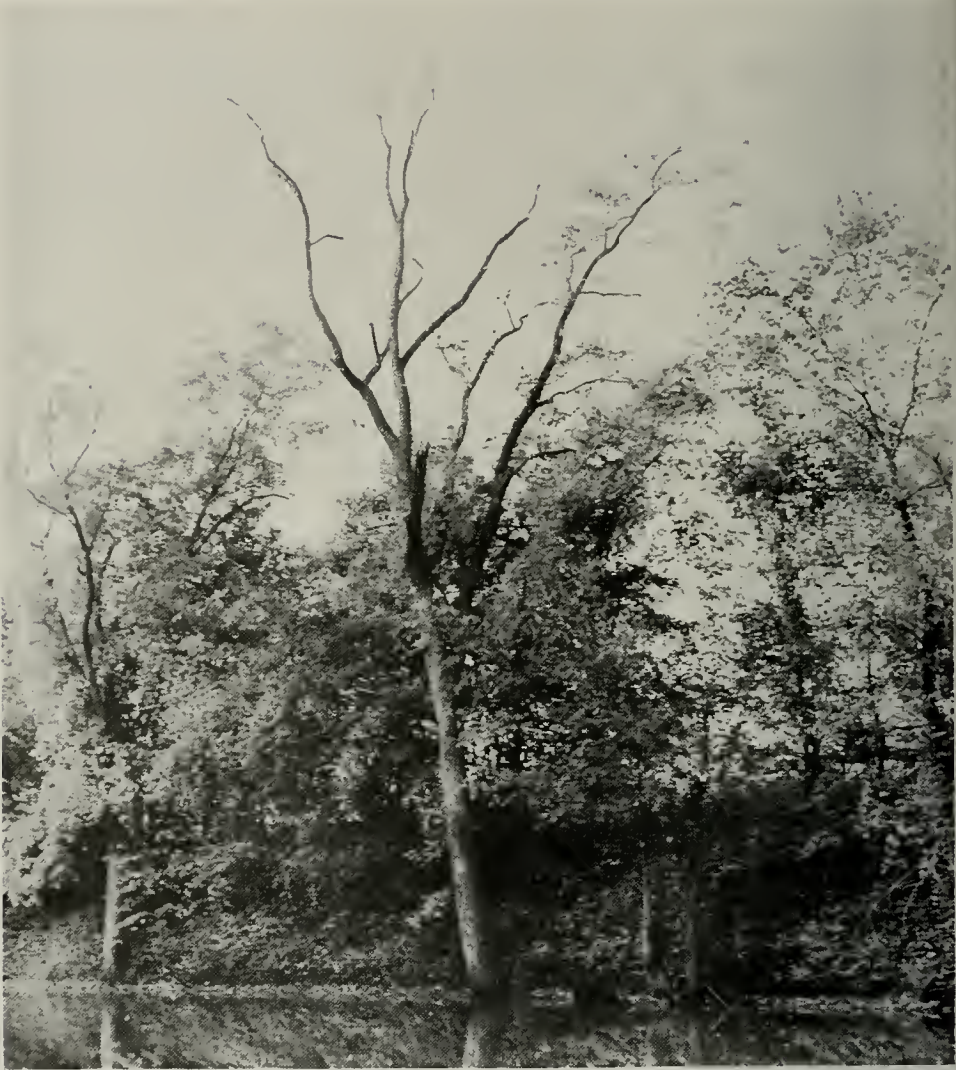
Fig. 10.—Some pecans and other trees with root collar flooded on one side but above water level on the other side died first on the flooded side.

Differential rates of dying in parts of the same tree were commonly noted. This condition occurred where trees grew on the shores of steep-banked sloughs, in such position that the root collars were flooded on the stream side, but lay above the post-flooding level on the land side. Pecan, fig. 10, showed this differential dying phenomenon most frequently, but the same condition was noticed also in elm, cottonwood, and maple. A score or more of partly dead trees were observed on the banks of Big Slough in October, 1946; it seemed probable that most of these would die in time.

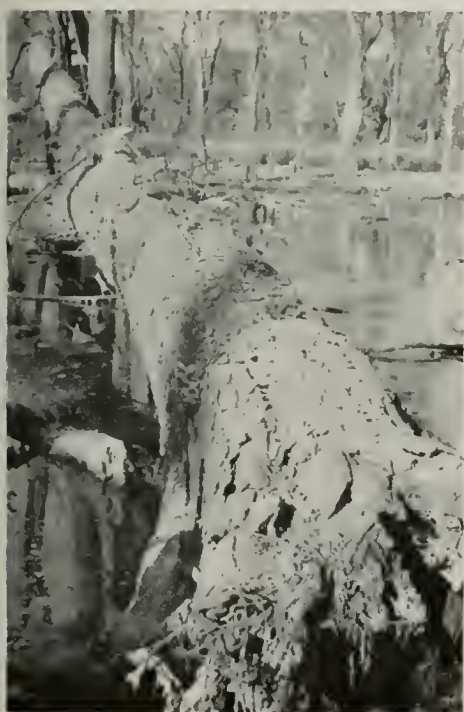
Fig. 11.—Silver maple wind-thrown in 1940, about 2 years after initial inundation of the Calhoun County study area. Photographed in October, 1940.

rapid decay in this low, humid locality, figs. 11 and 12. Falling data are summarized in table 7.

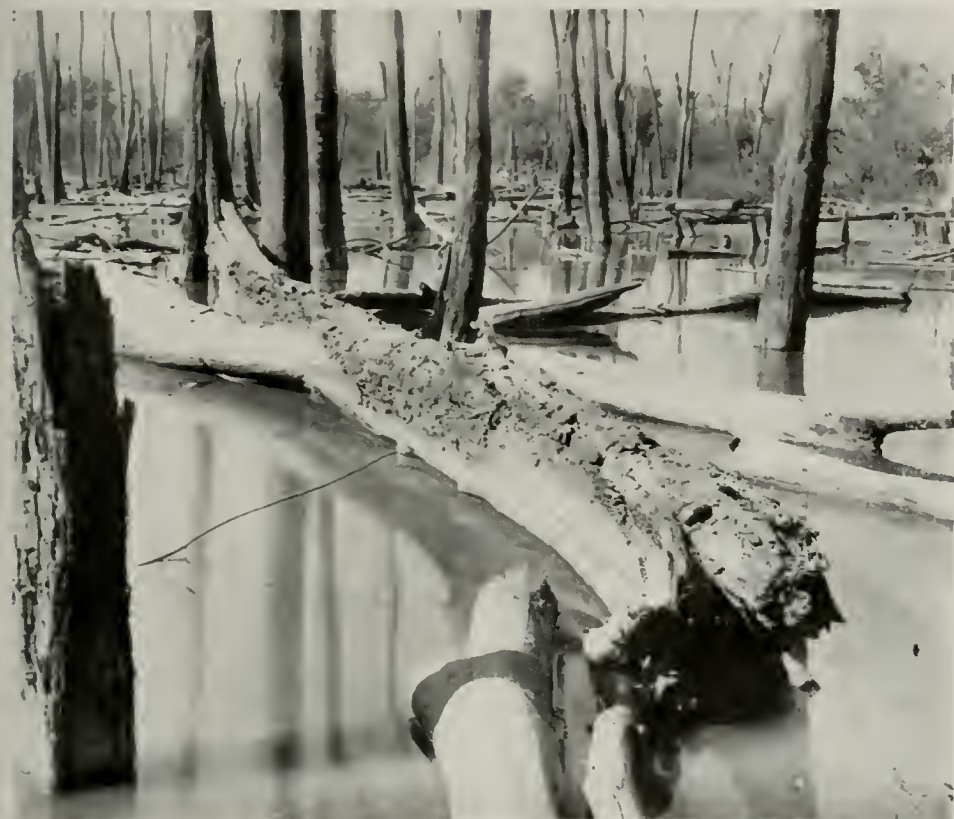
Fig. 12.—Same log as in fig. 11, October, 1946. Dying in 1939 and falling in 1940, this maple showed advanced decay and disintegration, to be expected of nondurable woods in low, humid localities in the temperate zone.

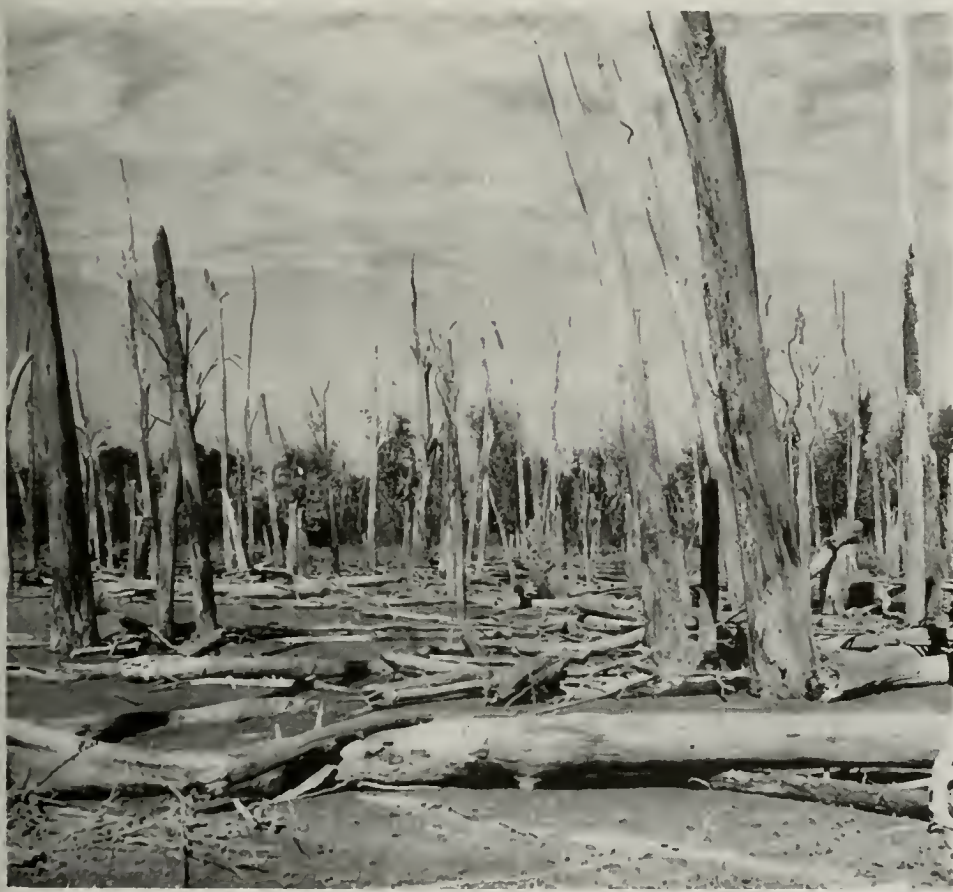
Fig. 14.—A silver maple stand, October, 1946, 8 years after inundation, showing falling and break-off characteristic of species having nondurable heartwood.

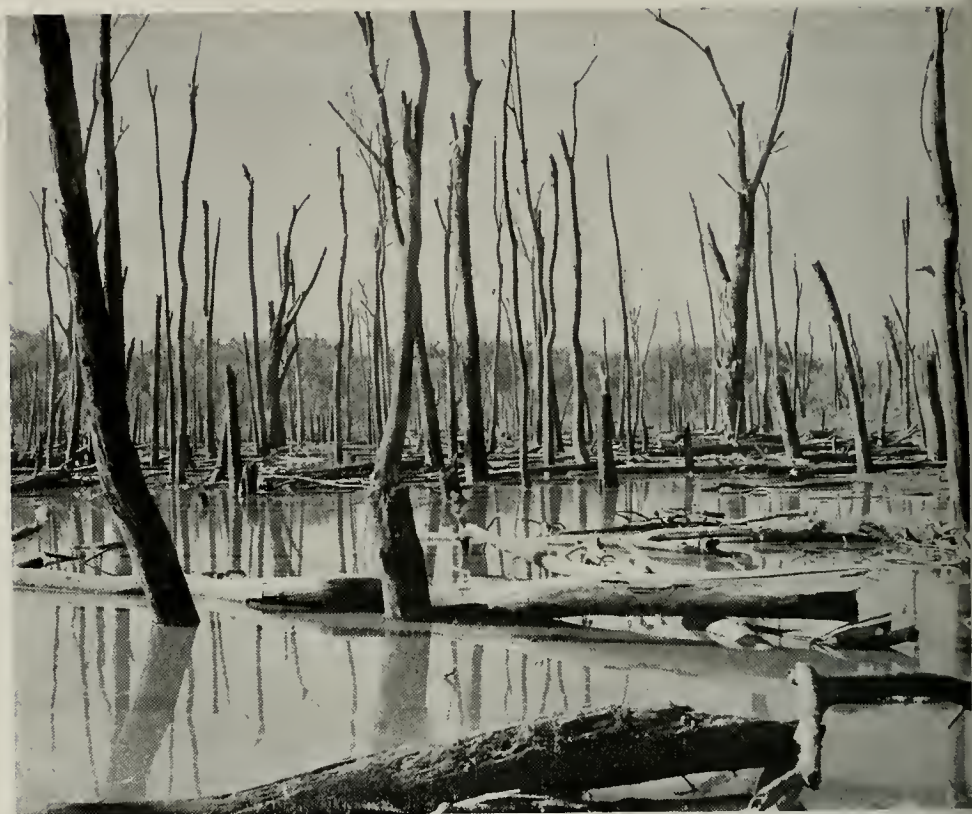
Fig. 15.—Silver maple "flat," flooded in 1938; a maze of fallen debris in October, 1946.

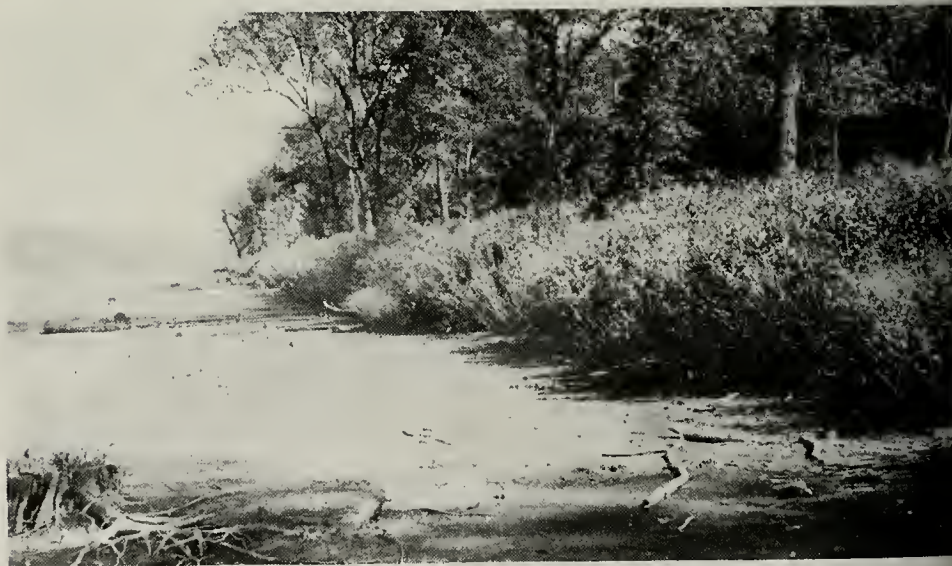
Fig. 16.—Stand of smartweed (*Polygonum* spp., chiefly *lapathifolium*) along the Illinois River on Calhoun Point, October, 1941. Seed presumably "windrowed" by wave action.

dred or more blinds scattered through the 4-square-mile area resulted in widespread shooting almost daily during each hunting season. Because waterfowl were thus discouraged during the fall in their attempts to use the new marsh and flooded woodland, evaluation of the area for waterfowl purposes has been complicated. However, the tract became potentially more attractive to dabbling ducks in its flooded state than it was formerly, because of the larger shallow water area and the development of rice cutgrass, fig. 17, smartweed, fig. 16, wild millet, and other aquatic and moist-soil plants that furnish food for ducks.

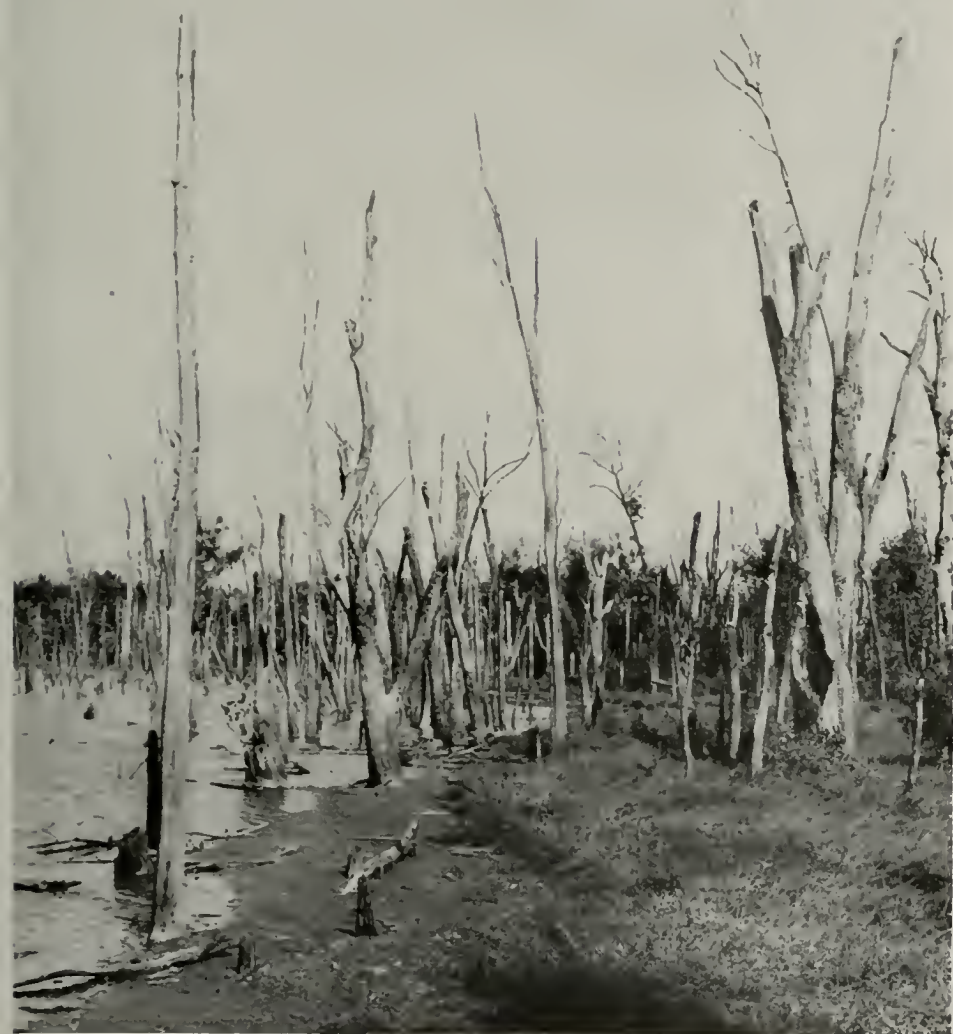
Fig. 17.—Rice cutgrass had attained luxuriant stands along the margins of flooded woodland in the study area by October, 1946.

stands had appeared in a scattered pattern on most of the water areas, as well as on wooded sites (timber dead) where the water table approached the ground surface, fig. 8. Stands of duckpotato (*Sagittaria* spp.) were particularly abundant along the lower end of Big Slough, where the channel had been deepened. Along the shore lines of both the Illinois and Mississippi rivers, rows of smartweed (*Polygonum* spp.) and cockspur or wild millet (*Echinochloa* spp.) appeared in both mixed and pure stands, undoubtedly due to the windrowing effect of wave action, fig. 16. Luxuriant growths of rice cutgrass (*Leersia oryzoides*) developed along the margins of many flooded areas in 1946, fig. 17.

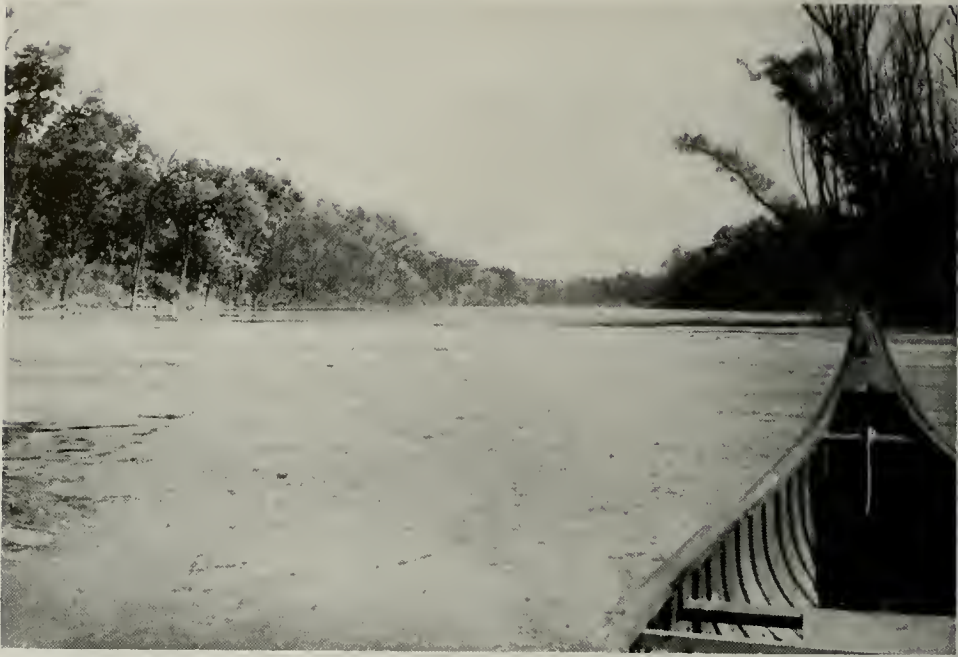
Fig. 18.—Mat of duckweed an inch thick covered much of Royal Lake, Calhoun Point, October, 1941.

1942. Very heavy stands of sedges (*Carex* spp.) sprang up along some of the more open sloughs and shallow-water areas. The water supported a layer of duckweed (*Lemna*, *Wolffia*, and *Spirodela*), commonly 1 inch thick, figs. 6 and 18. Filamentous algae covered every submerged object, fig. 19.

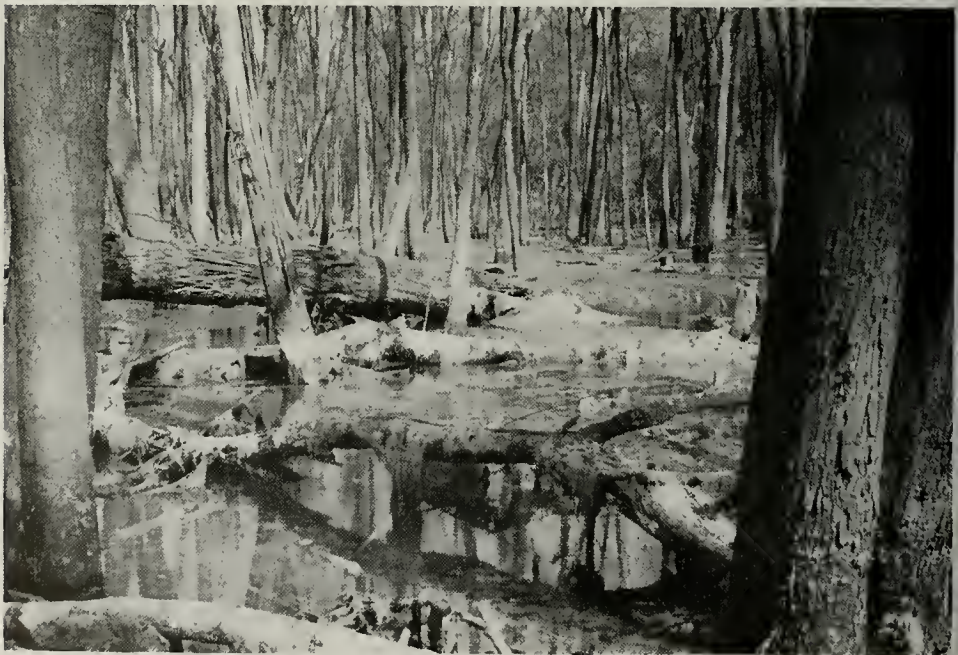
Fig. 19.—Filamentous algae grew in heavy mats over every submerged object, here revealed by a 16-inch drawdown, October, 1940.

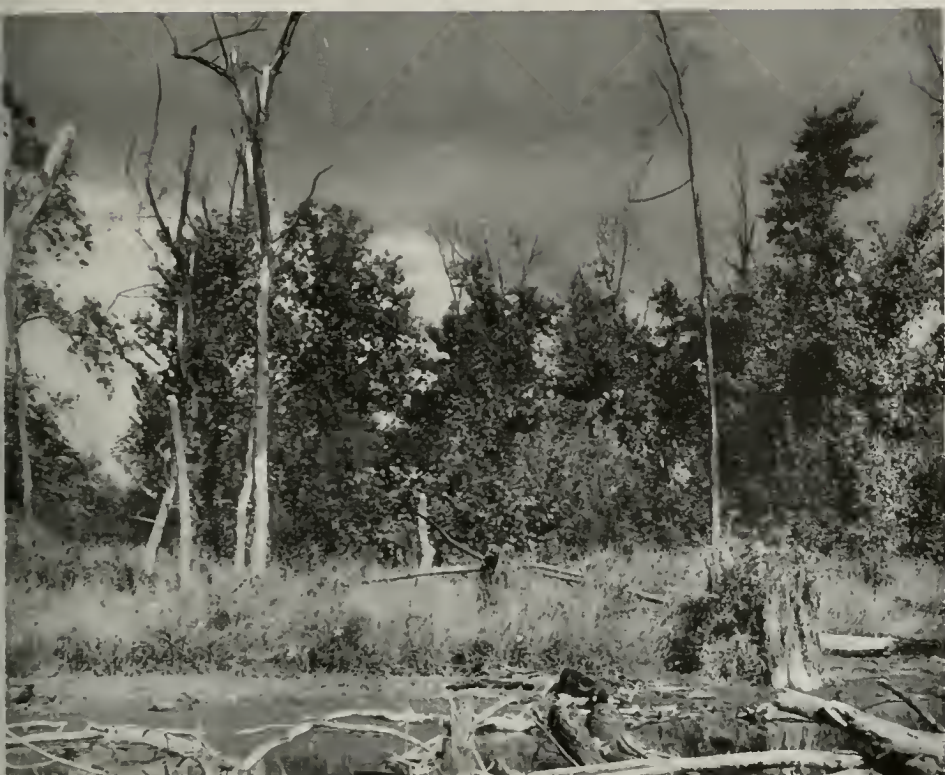
Fig. 20.—Willow, cottonwood, elm, and silver maple reproduction on mud flat following death of most of the original stand as a result of flooding that raised the permanent water level nearly to the ground surface. A luxuriant stand of rice cutgrass grew between the bare mud flat and the forest zone in October, 1946.

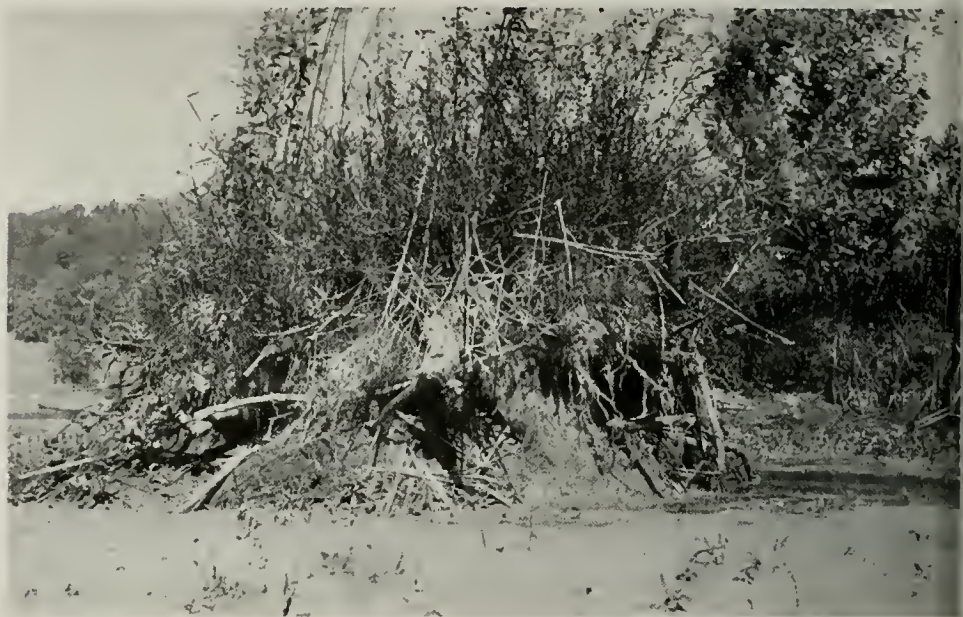
Fig. 21.—Muskrat burrows under an old stump exposed by a drawdown of the water level of the Illinois River at Calhoun Point, October, 1940. The animals had attempted to plug entrances following exposure.

Bellrose, Jr., of the Illinois Natural History Survey (personal communication) found no sign indicating the presence of these animals. In April of that year, temporary closing of the Alton Dam flooded the borrow pits and sloughs along the rivers, and within a few days muskrats appeared. Muskrat signs were fairly common on June 2, 1938, and in places abundant in October of the same year. Strong evidence was found during the next 3 years that muskrats were increasing in numbers. By October, 1940, muskrat cuttings (chiefly of cattails and sedges), droppings, and burrows were noted in or near practically every slough on the area, fig. 21.
